INCIDENT TYPE:

ELECTRIC SHOCK TO SW OPERATIVE AT LOCHCARRON WTW

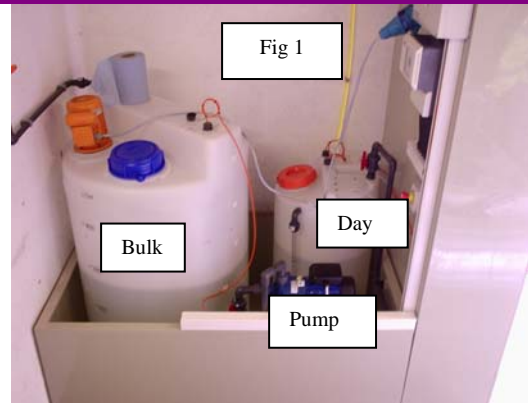
Investigation into this incident showed the following. Fig 1 refers

Both the bulk and day tanks contained water from the offline commissioning. The bulk tank was emptied first. Once empty it was then filled with the necessary 10:1 mix of ammonium sulphate solution and the static mixer on the tank switched on. The day tank and all the interconnecting pipework were then also emptied of water. The transfer pump between the bulk tank and the day tank was switched on to fill up the day tank with the mixed solution. With the draining of all the pipework there was a need to re-prime the pump and with the pump still running, the union coupling on the discharge pipe from the pump was loosened. This successfully bled the air but when the solution came out at the joint the SW operative felt a small shock and jumped back. At the time it was not thought that the shock came from the electrics and it was put down to static electricity. The fitting was tightened up and the day tank started to fill with solution. The transfer pump was switched off once the day tank was full.

The outlet valve on the day tank was opened to fill the calibration pot and it was found that due to the location of the pot it was only possible to half fill the pot. It was then advised that the SW operative should take the solution from the bulk tank to top up the level in the calibration pot. The SW operative inserted a plastic jug into the bulk tank solution and when his hand touched the solution, he received a greater shock than the previous one. This caused his arm to be kicked back against the side of the tank opening and he immediately jumped back from the dosing rig. The mixer was stopped at the HMI and removed its plug from the socket.

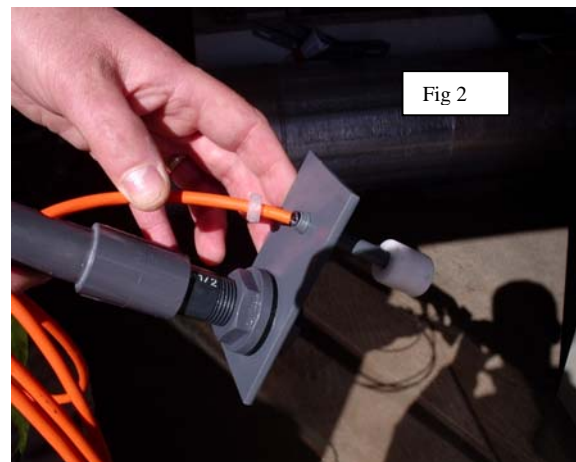
After lengthy investigation, it was discovered that the low level float switch on the bulk storage tank was faulty (fig 2). This switch is operated at 110v. In normal operation it is completely submerged within the bulk tank.

Where the 110v cable enters the float switch, it was found that cable outer sheath was outside of the gland and the inner live cores were exposed. This effectively made the entire contents of the bulk tank live.

Because the tanks and associated pipework are plastic, there is no way of earthing them, therefore the RCD for the switch failed to trip.

How the inner core came to be exposed has not been established.

The switch is made by Prominent and is part of an SWS Signature design. It was installed by Proshield. Proshield are now recommending that all future switches are operated on 24v. This is currently being discussed within SWS.

All previously installed equipment of this type must now be checked to ensure that the glands on the float switches are intact and that the electrical integrity of the plant is maintained.
