Introduction

In September 2006, Anglian Water suffered a sudden and catastrophic failure of a concrete tank at a sewage treatment works in Lincolnshire.

A Safety Bulletin was issued to all Solutions staff, Delivery Partners and Associate Delivery Partners, followed by an initial Advice Sheet. This Second Advice sheet is being issued to inform of the results that were found.

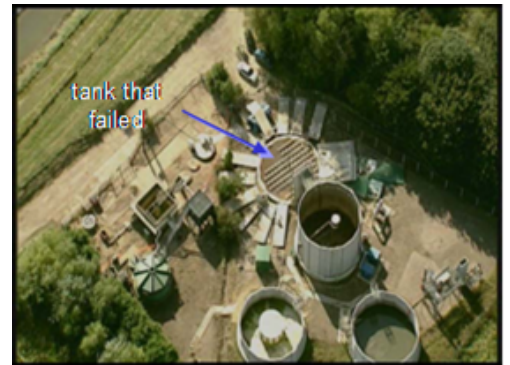
4. A-Consult appear to blame this water test as the major factor leading to water ingress to the tendons which eventually led to the stress corrosion cracking failure of the tendons. *"if it is considered absolutely necessary to utilise pressurised water injection into ducts to establish water tightness then it is necessary to remove that tendon and replace it with a new one"*.

(Motts made reference to tendons fabricated from Spanish steel, and particularly mentioned that all of the instances where corrosion was evident the tendons were made from this steel. They also said in their survey that tendons which used British steel did not show any signs of corrosion. Motts also mentioned that in laboratory tests the grease used with the Spanish steel emulsified in water. This could be a major factor in the creation of the corrosive conditions).

All parties who have investigated this incident agree that the ultimate failure was caused by stress corrosion cracking, but it is not possible with the limited information supplied to say exactly what caused it. Clearly pressure water testing the ducts will have put the water resistance of the tendons under extreme conditions and whether this was reasonable is questionable.

Tanks which are sufficiently partially buried would not pose any danger of collapse and could be considered as safe to use.
