**INCIDENT TYPE:**

RIDDOR MAJOR INJURY WHEN “BUCKET” FROM A TRACKED 360° EXCAVATOR BECAME DETACHED FROM ITS “HITCH”

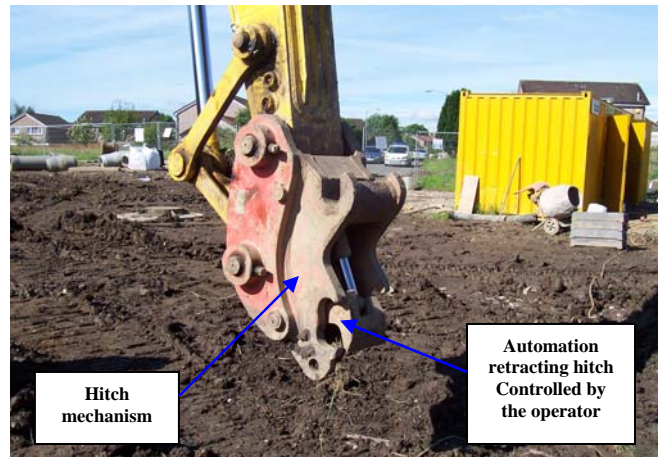
Hitch mechanism

Unfortunately, the operator failed to undertake this visual check and consequently failed to notice that, in this instance, the “bucket” had not been locked in position by the hitch. At this point the bucket remained firm under its own weight and therefore did not give any visual indication that it was not secured. Similarly, when the operator rotated his machine through 180 degrees (causing the bucket to hang over the excavation) it did not give any indication that the bucket was loose.

Automation retracting hitch Controlled by the operator

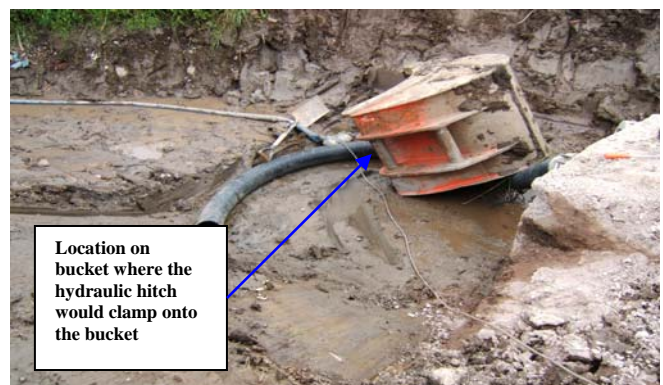
Location on bucket where the hydraulic hitch would clamp onto the bucket

The route cause of this accident was operator error. By undertaking the visual check the operator could have easily noticed that the “bucket” had not been engaged properly and consequently the accident avoided. The operator was subsequently subject to internal disciplinary procedures.

**All plant operators throughout the USCO have been briefed on the incident and re-briefed on the precautions to take when replacing “buckets”.**
