INCIDENT TYPE:

Serious “Near Miss” 2.5t TANK FALLS OFF DELIVERY TRUCK

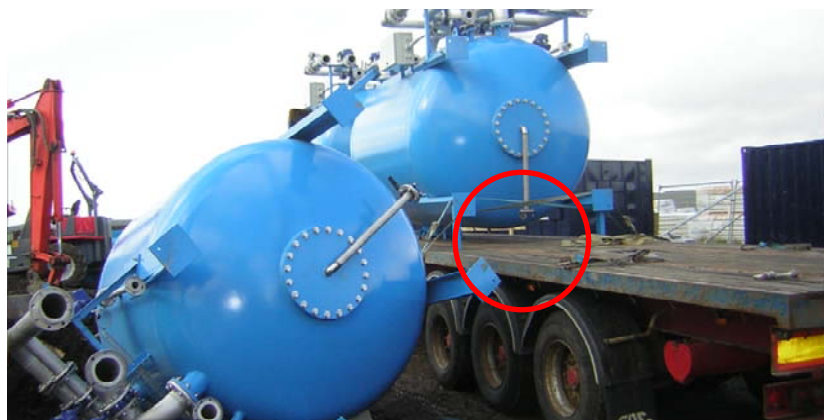
During the off-loading of three 2.5T water filtration tanks one of them rolled off the “bed” of its transportation wagon as its final transit strap was removed. (See picture above)

The investigation which followed discovered that the direct cause of the incident was the loss of a temporary support leg which had become detached from the tank itself at some point during transit. These legs had been purposely designed to allow the tanks to be laid at 90 degrees to their normal position. This orientation was required to avoid any restricted height issues that may have arisen during transportation. The tanks were also “naturally” top heavy and therefore warranted being inverted during transportation. The picture opposite shows the temporary legs and how they are configured on a tank. It was one of these legs that had fell off thus causing the tank to become unstable once the transit straps were removed.

It is not known what caused the suspect leg to fall off however it has been suggested that the leg was secured with non locking bolts which had the potential to loosen when subject to vibration similar to that incurred during transportation. It should be noted that this is a hypothesis and not proven. It should also be noted that upon inspection a further two legs were found to be loose. This would suggest that the wrong bolts were used.

The loss of the support leg had immediate impact stability as this was being maintained by the transit straps.

At this point the tank was only being supported by the transit straps and when they were released the tank continued its rolling motion and rolled off the vehicle.

- Ensure all temporary works designs (TWD) are appropriate for the circumstances of their use. They should be clearly visible from the permanent works.

- The Designer makes all TWD information available. Any specific information which is critical when lifting should be made available by the Designer. This should form the initial stage of a Written Delivery Plan.

- The Driver should be informed or make him/her informed of any TWD that have a bearing on the safety of his/her load.
- The Driver should ensure that the temporary measures remain functioning during transportation. This should form part of a formal inspection regime. This would form the second stage of the Written Delivery Plan.

- Principal Contractors must have appropriate arrangements in place to manage the hazards/risks with deliveries to their projects.
- Prior to any off-loading those appointed to undertake the delivery off-loading activity should appraise themselves of the initial Written Delivery Plan and identify any unsafe situations that may have arisen during transit or that may arise during the off-loading activity (e.g. loss of stability). This should form the third part of the Written Delivery Plan.

- If the “Delivery Team” are unhappy or not satisfied that the load will not remain stable following the release of any transit straps then the load **MUST** be returned to the supplier. Information should be returned to the supplier noting the safety concerns. This would form the last part of the Written Delivery Plan.
