INCIDENT TYPE:

Serious “Near Miss”
2.5t TANK FALLS OFF DELIVERY TRUCK

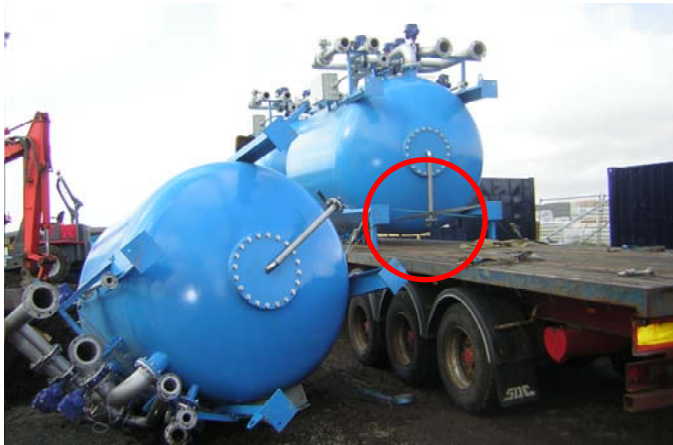
During the off-loading of three 2.5T water filtration tanks one of them rolled off the “bed” of its transportation wagon as its final transit strap was removed. (See picture above)

The investigation which followed discovered that the direct cause of the incident was the loss of a temporary support leg which had become detached from the tank itself at some point during transit. These legs had been purposely designed to allow the tanks to be laid at 90 degrees to their normal position. This orientation was required to avoid any restricted height issues that may have arisen during transportation. The tanks were also “naturally” top heavy and therefore warranted being inverted during transportation. The picture opposite shows the temporary legs and how they are configured on a tank. It was one of these legs that had fell off thus causing the tank to become unstable once the transit straps were removed.

It is not known what caused the suspect leg to fall off however it has been suggested that the leg was secured with non locking bolts which had the potential to loosen when subject to vibration similar to that incurred during transportation. It should be noted that this is a hypothesis and not proven. It should also be noted that upon inspection a further two legs were found to be loose. This would suggest that the wrong bolts were used.

The loss of the support leg had immediate impact stability as this was being maintained by the transit straps.

At this point the tank was only being supported by the transit straps and when they were released the tank continued its rolling motion and rolled off the vehicle.

- Ensure all temporary works designs (TWD) are appropriate for the circumstances of their use. They should be clearly visible from the permanent works.

- The Designer makes all TWD information available. Any specific information which is critical when lifting should be made available by the Designer. This should form the initial stage of a Written Delivery Plan.

- The Driver should be informed or make him/her informed of any TWD that have a bearing on the safety of his/her load.
- The Driver should ensure that the temporary measures remain functioning during transportation. This should form part of a formal inspection regime. This would form the second stage of the Written Delivery Plan.

- Principal Contractors must have appropriate arrangements in place to manage the hazards/risks with deliveries to their projects.
- Prior to any off-loading those appointed to undertake the delivery off-loading activity should appraise themselves of the initial Written Delivery Plan and identify any unsafe situations that may have arisen during transit or that may arise during the off-loading activity (e.g. loss of stability). This should form the third part of the Written Delivery Plan.

- If the "Delivery Team" are unhappy or not satisfied that the load will not remain stable following the release of any transit straps then the load **MUST** be returned to the supplier. Information should be returned to the supplier noting the safety concerns. This would form the last part of the Written Delivery Plan.

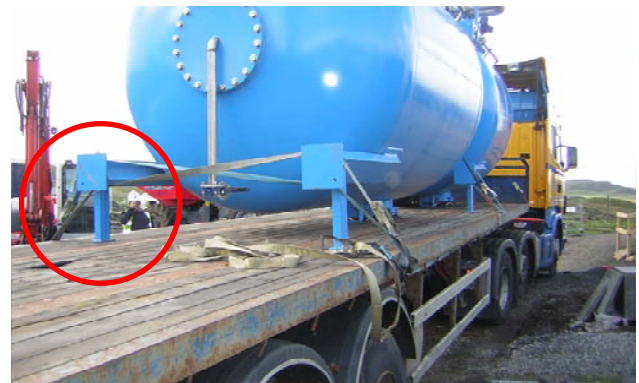
It was also noted that the delivery of the three tanks began in France where they were manufactured and involved two haulage companies. This logistic required the equipment to be off-loaded and re-loaded onto another delivery wagon.
