INCIDENT TYPE:

LIFTING EQUIPMENT – CHAIN BLOCKS

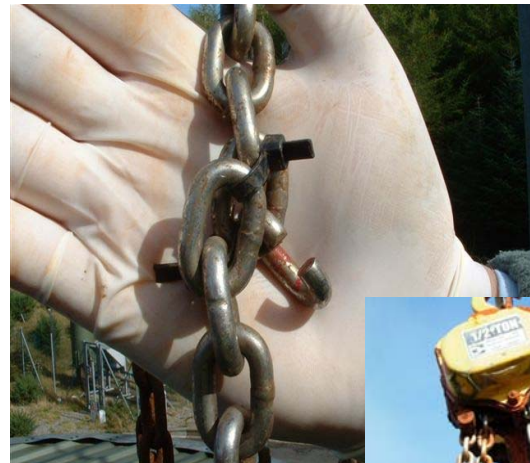
A number of chain blocks have been found where the pulley chains have been cut and rejoined using cable ties.

This modification shortens the chain length attached to the anchor point on the the block. This length of chain can become load bearing if it passes through the block. In this case, the load would fall and there is a high risk of injury to persons or damage to the load being carried.

Modifications to lifting equipment by unauthorised personnel are effectively illegal – the modification shown above has been reported to the Health and Safety Executive and may lead to Scottish Water being prosecuted. Persons making these modifications are placing themselves and others at risk.

Scottish Water staff **MUST NOT** modify lifting equipment. If you are aware that any lifting equipment you use has been modified in any way, you **must** immediately stop using that equipment, remove it from use, mark it “DO NOT USE” and inform the person responsible for carrying out Thorough Examinations of lifting equipment.
