## INCIDENT TYPE:

## NEAR MISS – WHILST MAINTAINING A WASTE WATER AERATION BLOWER UNIT

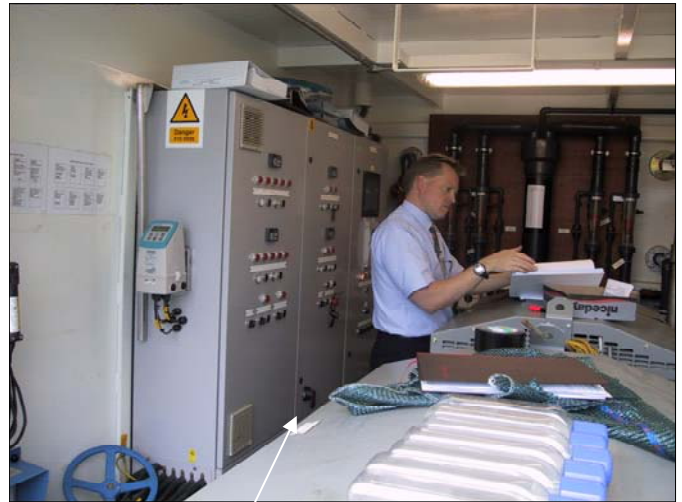
*The main isolator*

1. This equipment is package plant but is not part of any framework agreement and its isolation provision must be checked.
2. Isolation techniques should match requirements of The Electricity at Work Act 1989 and SW Specifications.

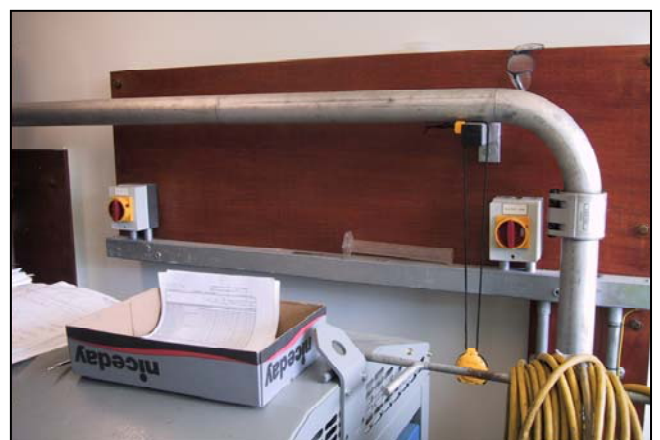
The blower control panel has a ventilation fan as well as the main blower. They can both be isolated at the main panel but in addition to this there is a local isolation switch labelled "Blower 001". The operative used this local switch for isolation but it actually only isolated the ventilation fan. The main fan was still live but with no warning to this effect.

### Local isolator

1. What method of isolation has been designed? (The emergency stop is not considered a method of isolation)
2. Where there is more than one method of isolation, have all the circuits and electrical equipment been covered by both types of isolation?
3. Are the isolation switches correctly labelled?
4. If the plant has been commissioned have these systems been tested prior to certification and handover?
5. Do the as-built drawings accurately record the actual electrical installation?
